Regulator Box & Dynamo Fault Diagnosis Notes.

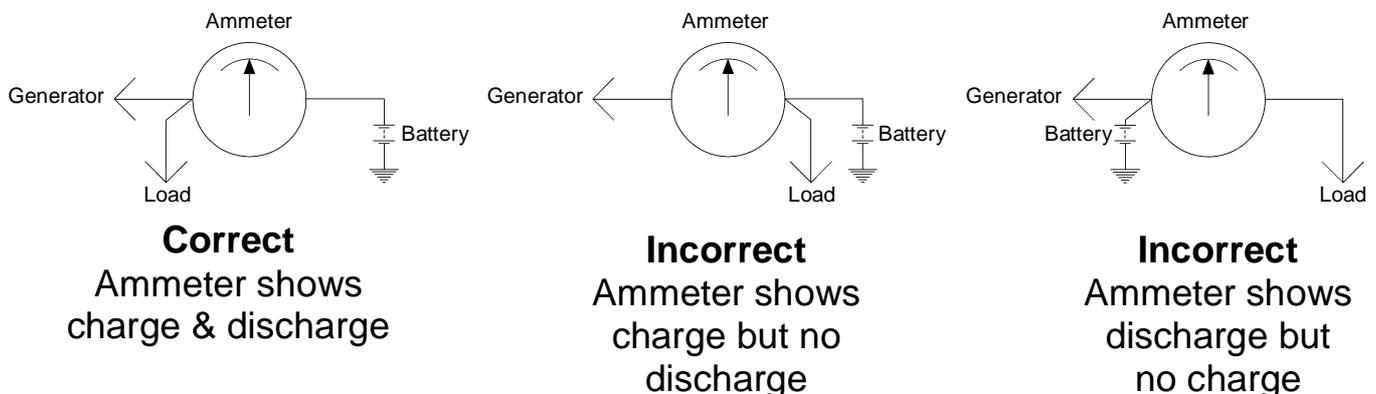
Ammeter readings – correct and incorrect

Ammeter wired up correctly but dynamo not charging. Manual closing of cutout points without engine running showed a discharge on ammeter, manual closing of cutout points with engine running at charging speed showed a greater discharge on ammeter.

Dynamo wired for opposite rotation.

Change field connections over **OR** change the brush connections over.
